Contract #: 04-0120F4Cty: SF/ALA Rte: 80 PM: 13.2/13.9File #: 13.28**WELDING INSPECTION REPORT****Resident Engineer:** Pursell, Gary**Address:** 333 Burma Road**City:** Oakland, CA 94607**Report No:** WIR-012996**Date Inspected:** 13-Apr-2010**Project Name:** SAS Superstructure**OSM Arrival Time:** 1000**Prime Contractor:** American Bridge/Fluor Enterprises, a JV**OSM Departure Time:** 1830**Contractor:** Oregon Iron Works Clackamas, Or.**Location:** Clackamas, OR

**Hinge-K Pipe Beam Assembly 120A-2:**

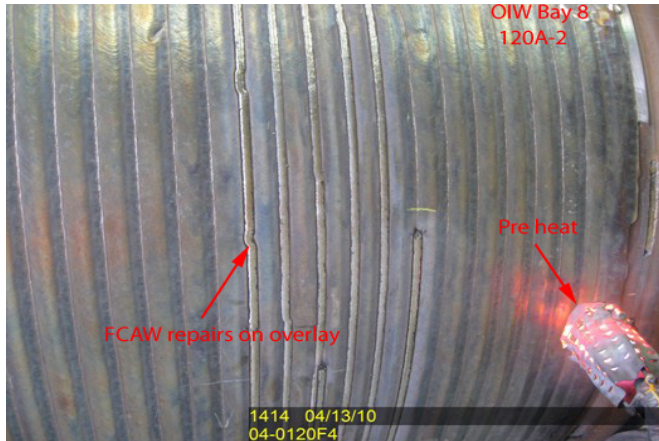
The QA Inspector witnessed WID #F17 (Igor Frolov), in-process of performing Flux Core Arc Welding (FCAW) on the completed stainless steel overlay. WID #F17 explained to the QA Inspector that he was currently performing repairs on low spots, underfill and on the weld start/stops. The QA Inspector noted that QC Inspector Jose' Salazar was present and QC Inspector Salazar explained that the welding parameters were previously recorded at 160 amps/ 24.6 volts and the approved Welding Procedure Specification (WPS) 3293, was being utilized, for the repairs. QC Inspector Salazar explained that pre-heat was consistently maintained, utilizing a stationary torch, which was previously set-up. The QA Inspector randomly recorded pre-heat of approximately 150 degrees Fahrenheit, during the in-process FCAW performed by WID #F17. The QA Inspector noted that the FCAW appeared to be in compliance with WPS 3293 and after these repairs are complete, this Fuse will eventually be sent to AG Machine Works, for final machining. See attached picture below.

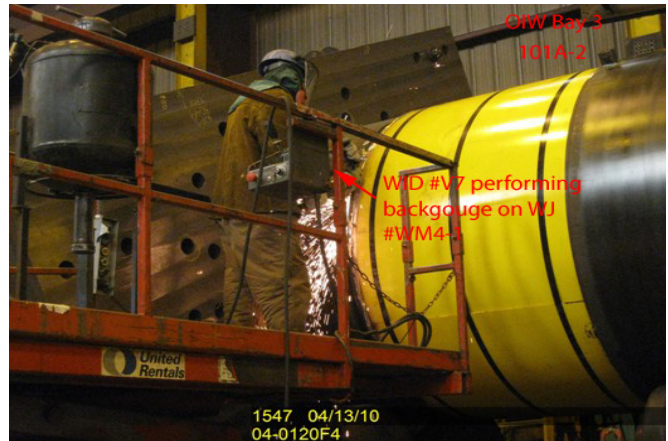
**Hinge-K Pipe Beam Assembly 101A-2:**

The QA Inspector witnessed production Lead Troy Smith and WID #B62 (Marcus Belgarde), performing the backgouge, on the previously completed root pass, designated as weld joint (WJ) # WM4-1. The QA Inspector noted that this weld joint was the 120A-1 Fuse to 102A-1 Forging and was designated as an AWS D1.5 B-U7-S

Complete Joint Penetration (CJP), double U Groove, with a 20 degree included angle bevel prep. The QA Inspector noted that Lead Troy Smith was performing the backgouge, utilizing the Carbon Arc process and that pre-heat was intermittently applied, with a stationary torch. The QA Inspector noted that QC Inspector Jose' Salazar was present and QC Inspector Salazar explained that the pre-heat was verified, prior to starting the Carbon Arcing. The QA Inspector noted that the minimum temperature required is 150 degrees Fahrenheit, per AWS D1.5. QC Inspector Salazar explained that the Carbon Arcing will continue and then mechanical grinding will then be performed, to grind the root pass to sound, clean metal. QC Inspector Salazar explained that the backgouging will continue to depth of approximately 65 mm and he will then verify the depth and perform 100% Visual and Magnetic Particle Testing (VT/MT) on the backgouge.
